## PRE SCHOOL WATER INTRUSION

**Owner:** Saint Mark  
Catholic Church

**Scope of Work:**  
Initial Evaluation  
Water Intrusion in to  
Cavity Walls

**Location:** Plano,  
TX

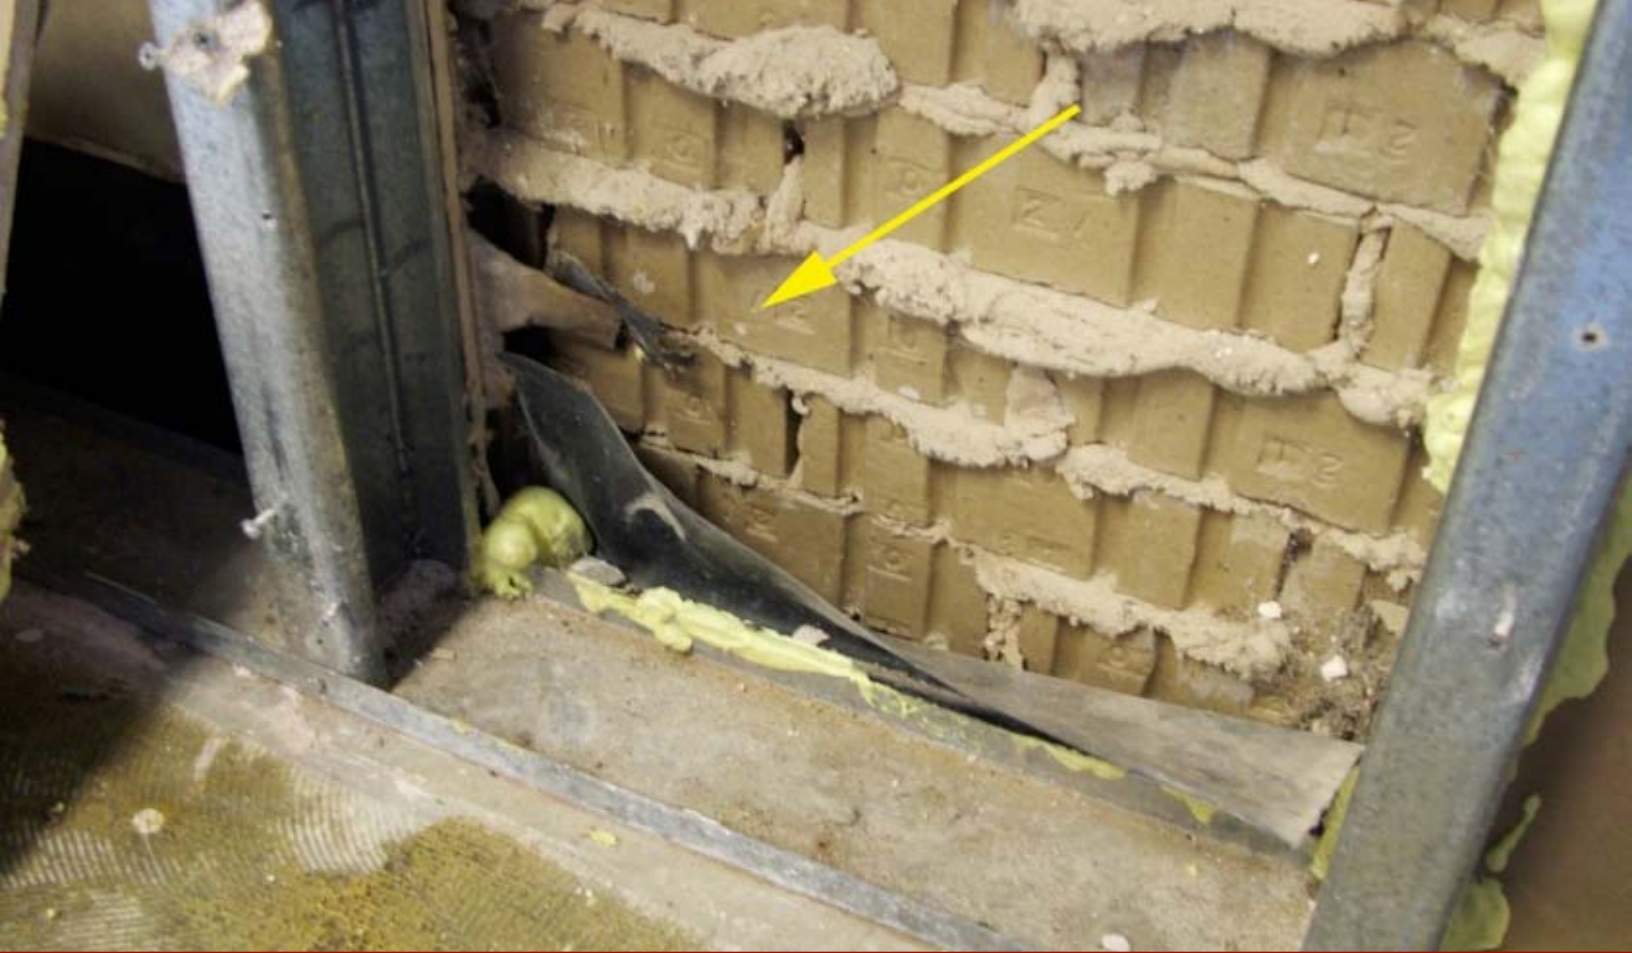
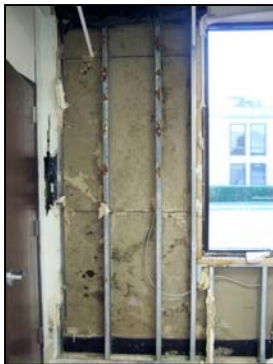
TBS provided an initial evaluation of currently deconstructed walls to determine to possible sources of moisture that promoted mold growth. Observations made on site found that the existing walls had very little drying potential due to the installation of two vapor barriers. The windows were not installed with pan flashing at the sills, and the landscaping next to the building has allowed vapor to enter the wall cavity behind the brick. We made recommendations for improvements that included, rebuilding the walls from the inside and providing an improved thermal barrier, a complete air barrier and a vapor barrier that allow a drying potential the inside.
