## KENNEBUNK MIDDLE SCHOOL WINDOW REPLACEMENT

**Scope of Work:** Window Replacement / Building Envelope Renovations

**Location:** Kennebunk, Maine

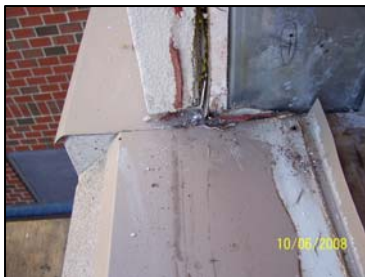
This six year old, two story, brick veneer and EIFS clad middle school has experience significant water intrusion at the window openings since it's completion.

The school suffered from multiple sourced long term moisture intrusion and water leakage problems centered on the single ply roof membrane, non flashed windows, poorly flashed penthouse walls as well as HVAC piping leaks and piping freeze ups. The windows and flashing problems have been addressed and HVAC systems have been repaired and adjusted.

Our nationally recognized team of building scientists were brought in to analyze the problem and develop long term, cost effective solutions. Through in-house water testing and fieldwork, and a close working relationship with the contractors, the team was able to execute a fix without major renovation cost to the owner. Detailed, step-by-step sequencing drawings and close on site collaboration assured the proper installation of the new design.
